Aircraft Full-Scale Test Program for the 1998/99 Winter

Transportation Development Centre

October 1999

**Michael Chaput,
Medhat Hanna,
Elio Ruggi and
Jeff Mayhew**

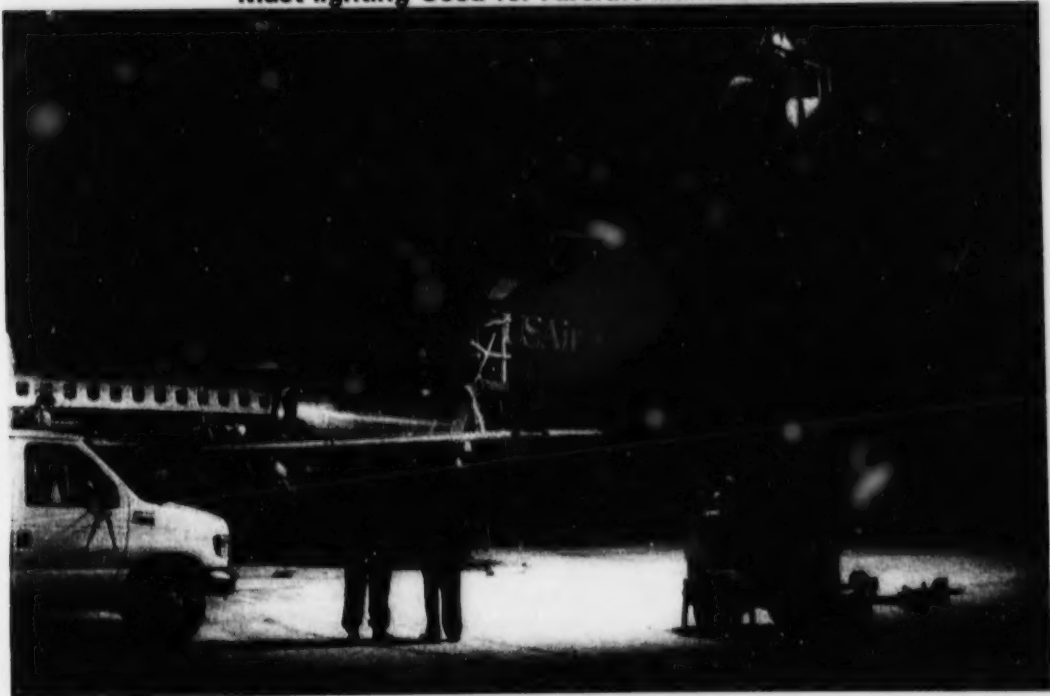
Photo 2.4
Mast-lighting Used for Aircraft Illumination

Six rolling staircases and several stepladders (see Photo 2.3) were to be positioned around each aircraft wing. Wing illumination was supplied by mobile mast-light units. Each unit consists of four 1 000W flood lights. A 6 kW diesel generator (an integral component of each unit) was also used to supply current for the lights and other electrical requirements. This lighting arrangement provides a significant improvement over those used prior to 1997/98 (with respect to light set-up time). Photo 2.4 shows the mast-lights ready for testing.

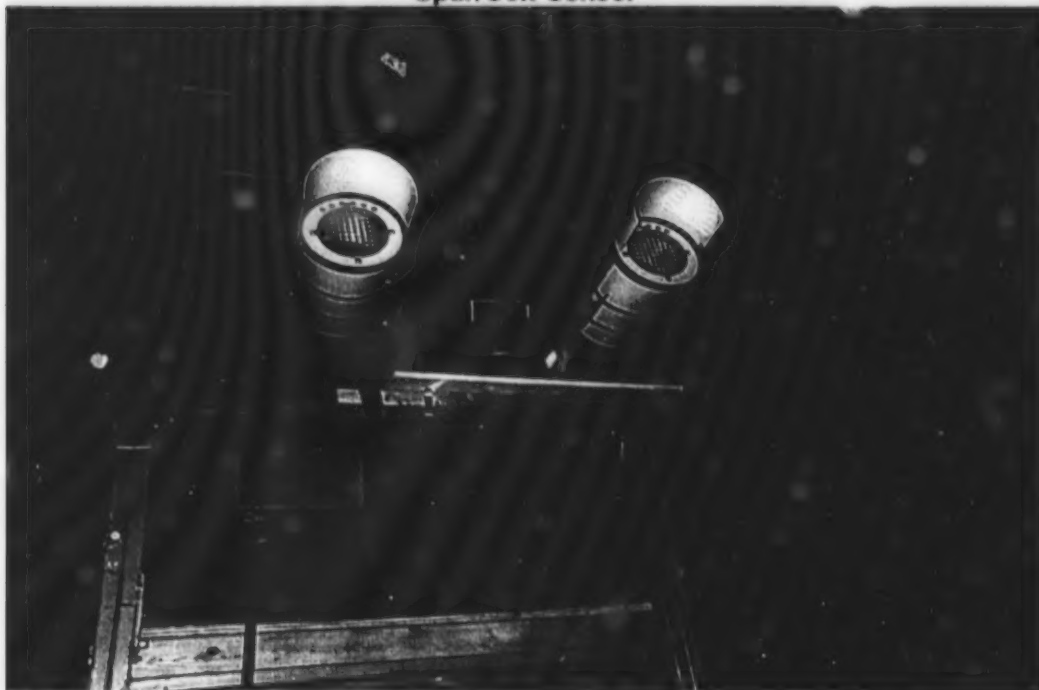
Photo 2.7
Spar/Cox Sensor

Photo 2.7 shows the Spar/Cox sensor. The unit uses infrared technology initially developed by Spar (but marketed and manufactured by Cox and Co.) to detect ice accumulation on aircraft surfaces from remote positions. The unit tested was not yet made available as a hand-held unit, and so for

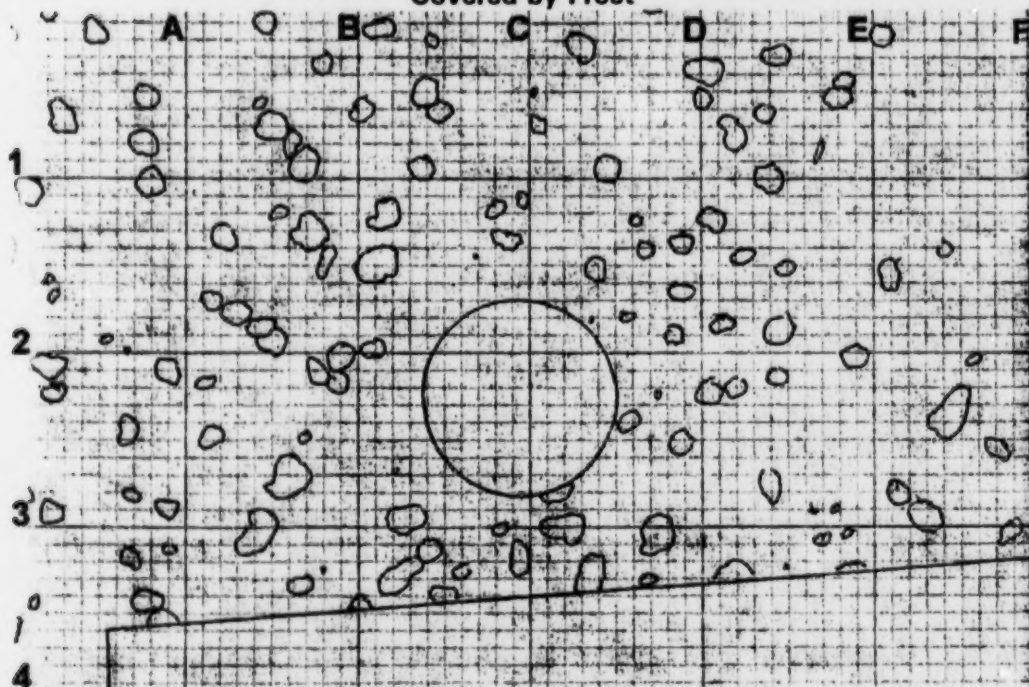
Transparent Grid used to Determine Frost Sizes and Surface Area Covered by Frost

Each large square represents 25.4mm (1 inch).

The average density of frost peaks per square centimetre in each of the wing sections was also calculated using the transparent grid.

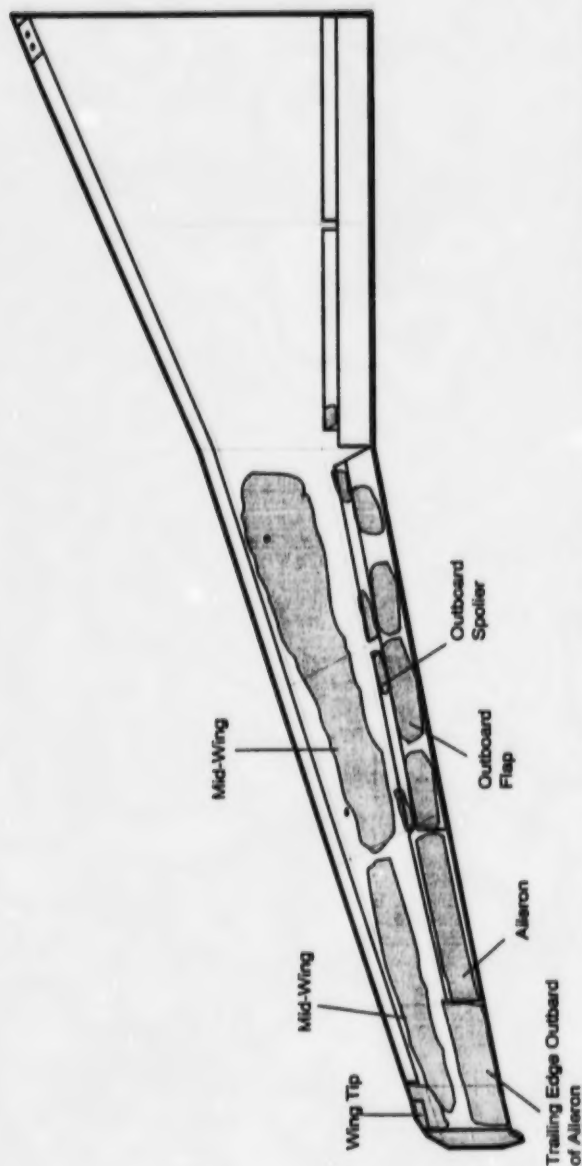
TABLE 4.1
 FROST DIAMETER, HEIGHT, SURFACE AREA COVERAGE, AND DENSITY
 ON A CL-65 WING (ID # 3)
 February 15, 1999

Wing Section	Average Frost Diameter (mm)	Surface Area Covered	Average Frost Height (mm)	Density Peaks/cm ²
Aileron	4	12%	0.2	2
Outboard Spoiler	3	9%	<0.2	2
Outboard Flap	1	6%	<0.2	4
Mid-Wing	3	8%	<0.2	2
Wing Tip	5	80%	0.5	NA
Mid-Wing	3	7%	<0.2	2
Trailing Edge Outboard of Aileron	> 5	94%	0.5 - 0.8	NA

Using the methods outlined in Sections 3.2.3.2 and 3.2.3.3, the diameter, height and surface area coverage of the frost deposits on the various RJ wing sections were estimated, and are shown in Table 4.1.

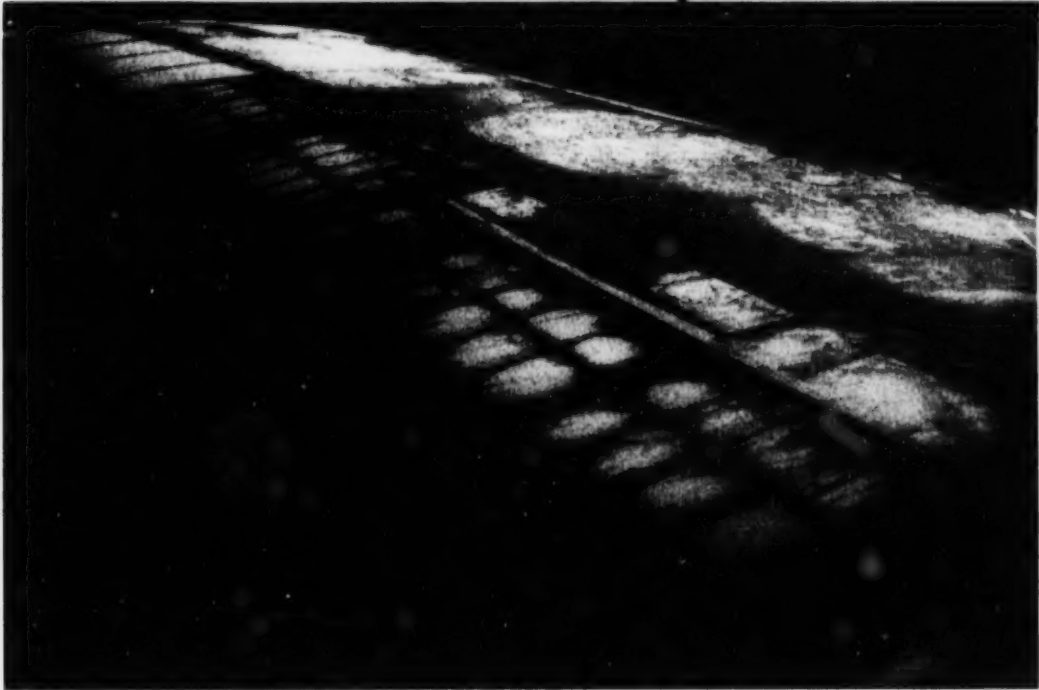
Photo 4.1
Frost Accumulation on Port Wing (ID# 1)

Figures 4.1 and 4.2 show the frost deposits that accumulated on the port and starboard wings of the RJ aircraft prior to the start of testing on December 5, 1998 (ID#1). On both wings, similar patterns of heavy frost were evident (Photos 4.1 and 4.2). Visual inspection revealed that frost accumulation on both wings was heaviest on the wing tip and trailing edge of the wing (outboard of the aileron - see Photo 4.3). Heavy accumulation was also present on the aileron, outboard flap, outboard spoilers, and on the mid-wing sections outboard of the inboard flap section. With the exception of small patches of contamination on the inboard flap, no frost was present on these surfaces. The inboard spoilers, inboard mid-wing sections, as well as the entire leading edges were entirely free of frost (see Photo 4.4).

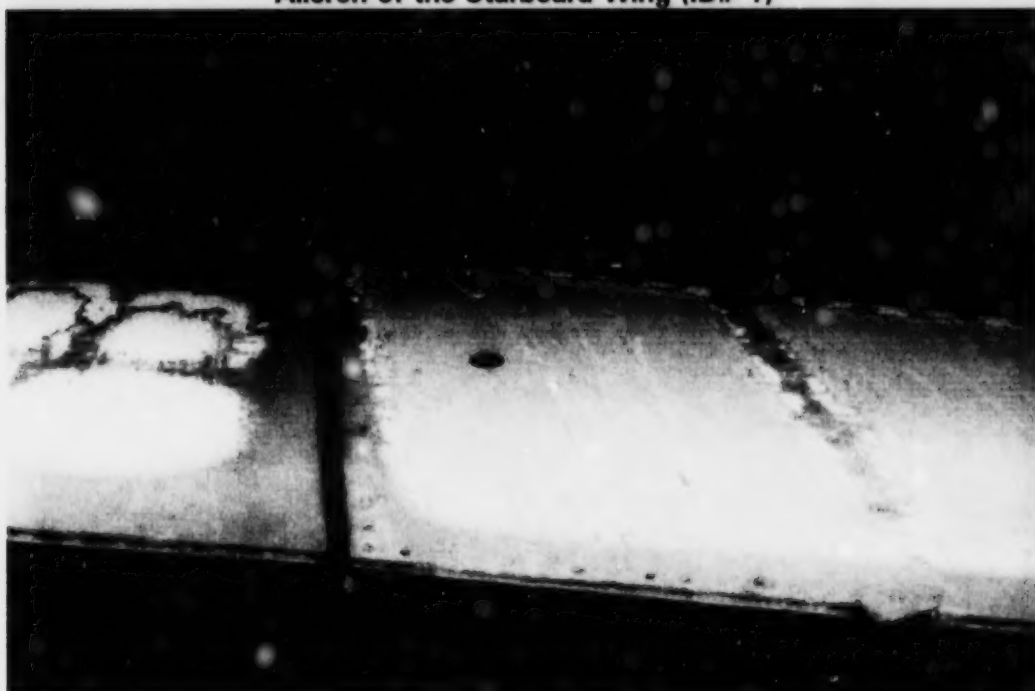
Photo 4.3

Heavy Frost Accumulation on the Aileron and Trailing Edge Outboard of the Aileron of the Starboard Wing (ID# 1)

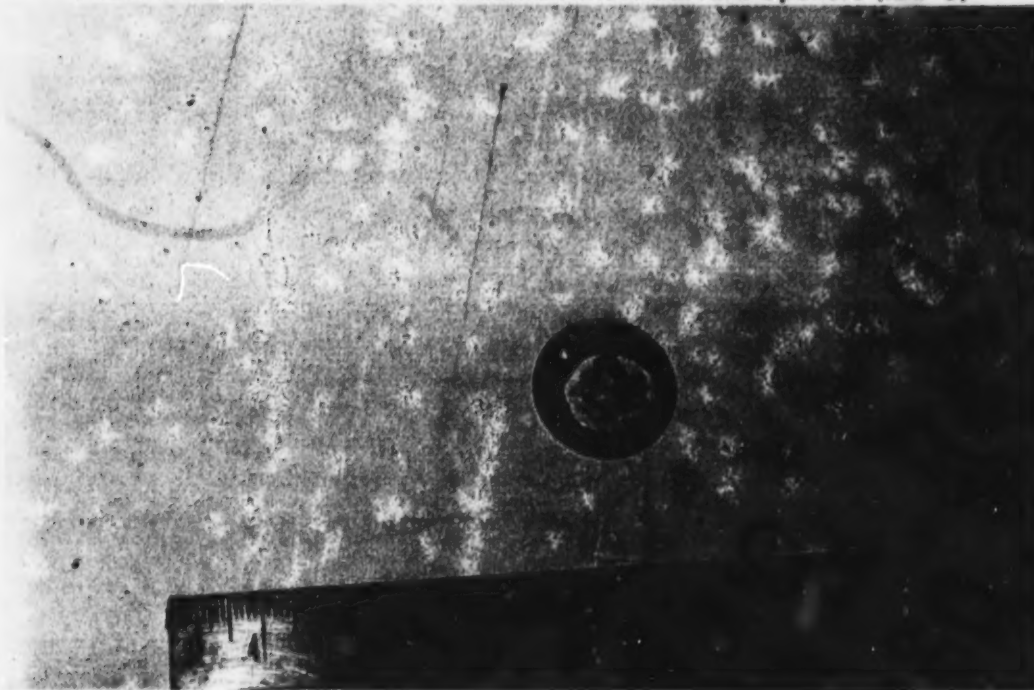
Plan Photo of the Frost Formation on the Outboard Spoilers (ID# 3)

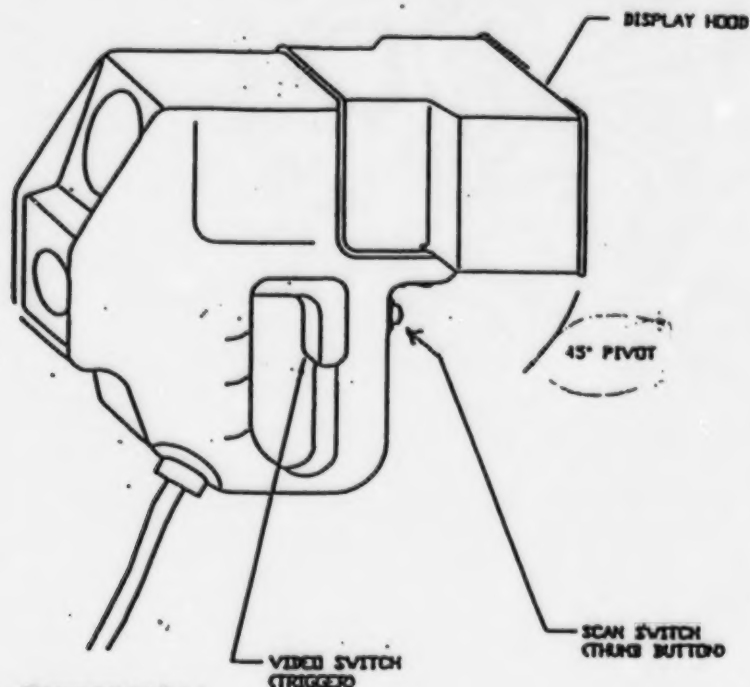
Fig - 2 ID-1H SENSOR MODULE A HAND HELD VIDEO SCANNING UNIT.

Video Switch (trigger)
Scan Switch
Adjustable Display Screen and Hood

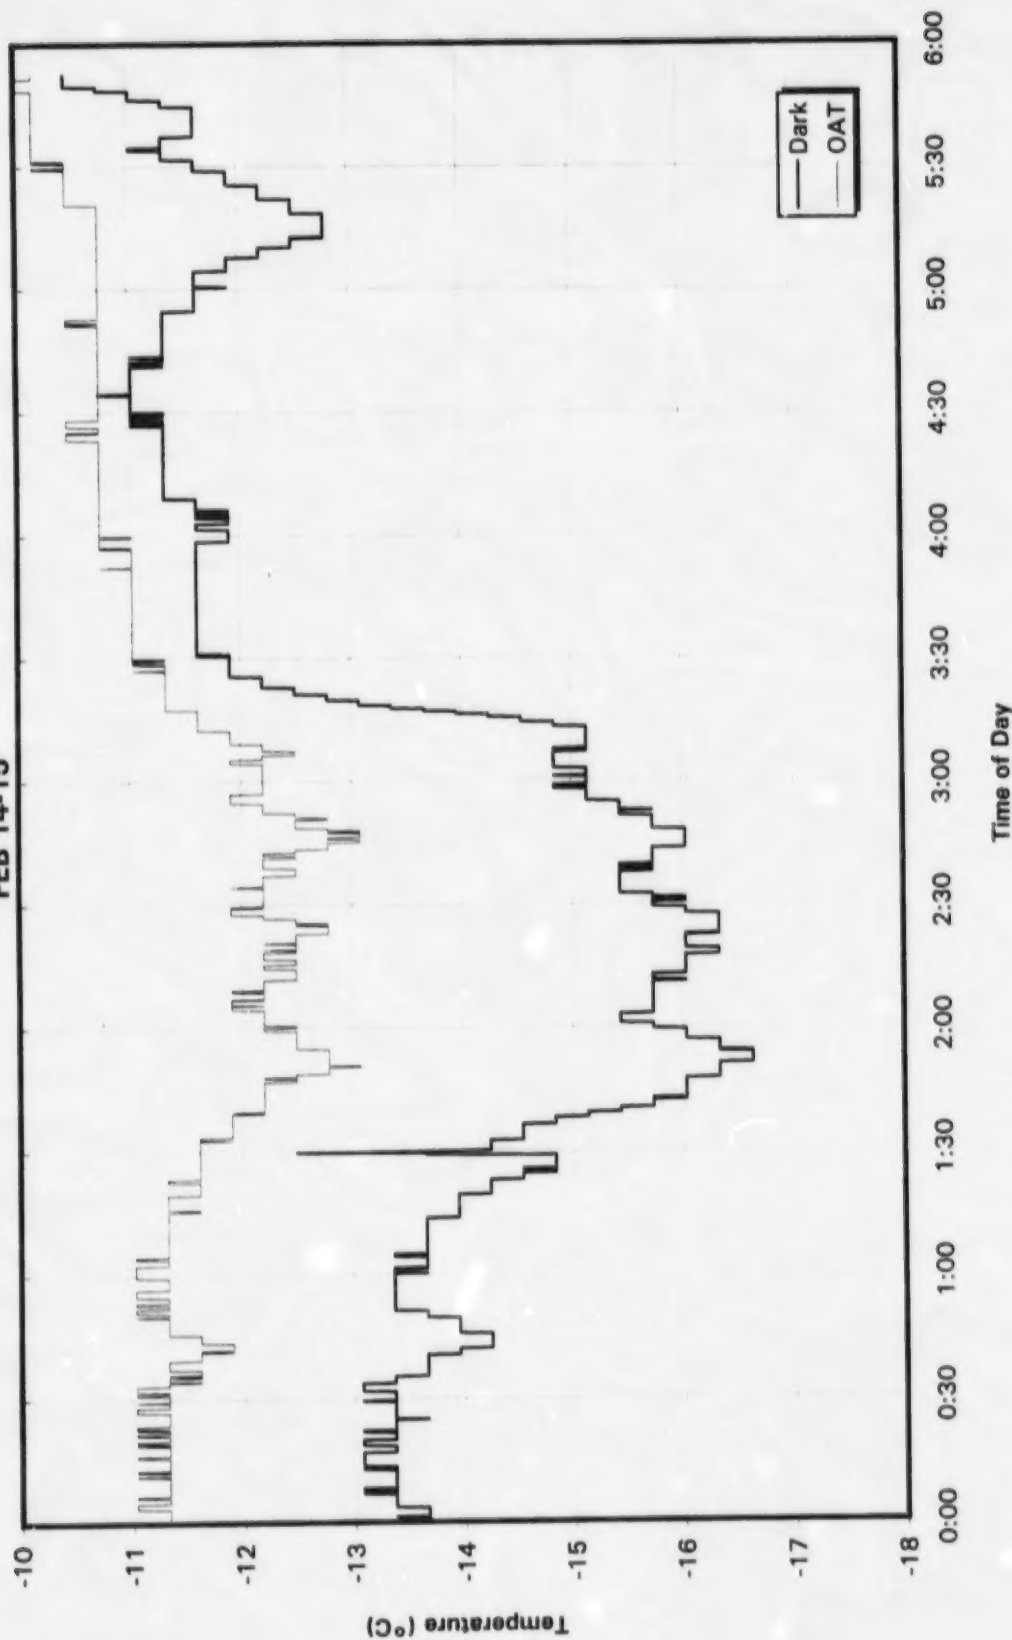
FIGURE 3.2

Unlighted Plate Surface Temperature vs OAT
